CORROSION TECHNICAL BULLETIN

NOVEMBER 2003 | Revision 4

Following trades

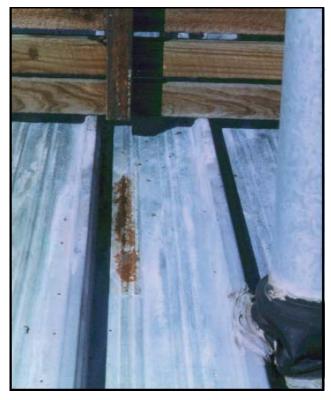
Figure 1:CCA treated timber walkway

The installation of surface mounted roof air conditioning units on copper/chrome/arsenic (CCA) treated timber or green hardwood dunnage and the installation of roof walkway systems similarly mounted on this style of timber dunnage must be avoided. Corrosion of the under lying roof sheeting in contact with the timber will be dramatically accelerated by the wet poultice and contaminants created by such poor practise.
