Flashing materials for exterior BlueScope coated steel sheet

Technical Bulletin 8

January 2021. Revision 10.
This issue supersedes all previous issues.

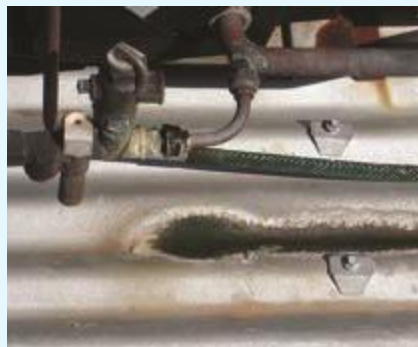
Bi-metallic corrosion of exterior BlueScope coated steel occurs when these products are in direct contact with copper, and from contact with “copper-rich” water run-off e.g. hot water system overflows (see Figure 1).

Figure 1: Bi-metallic corrosion caused by ‘copper-rich’ water run-off

Painting the outside of copper piping is recommended. Hot water discharge pipes should be extended beyond the roof, preferably to the ground.
