Identification of fungus in the field and recommendations for its removal

Technical Bulletin 27

May 2019. Revision 6.
This issue supersedes all previous issues.

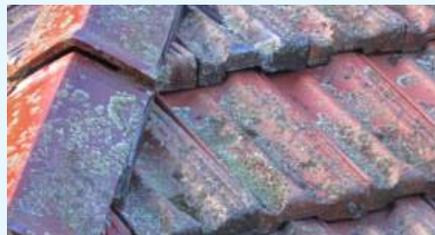
Figure 1: An example of lichenous growth across the surface of a tiled roof.

across the entire roofing surface. Figure 1 provides an example of lichenous growth on a tile roof.

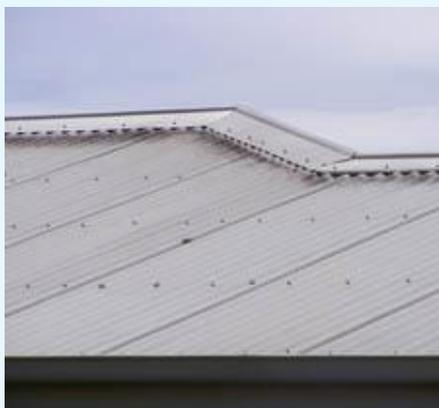
Figure 3: Roof made from COLORBOND® steel showing isolated fungal growth near the ridge capping.

Heavy areas of fungal infestation on a building are often seen around the ridge-capping. See Figure 3.

It is believed that this "ridge cap" effect is due to the favourable micro-environment for fungal growth which exists in this area because of moisture and/or nutrients leaving the roof cavity at the junction of the ridge capping and the roofing sheets.

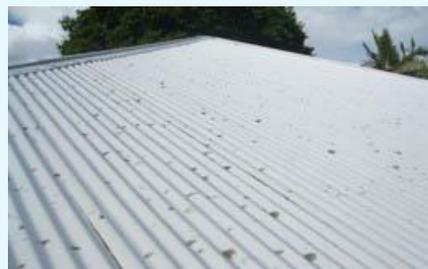
Figure 4: Roof made from COLORBOND® steel showing spotty lichen and fungus growth spread across the structure.

Organic material may be present as overall clumps or dots spread across the roof. This often manifests as patches of lichen. See Figure 4.

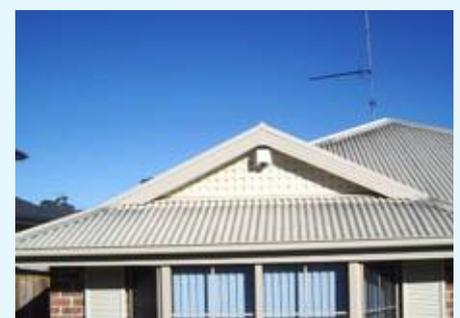
Figure 5: Roof made from COLORBOND® steel showing uniform coverage of fungus.

It is also possible for growth to not be isolated to any specific area but to cover the entire roof area. Such growth is normal on any outdoor structure where the local environment is conducive. When very heavy growth of this type occurs on lighter coloured roofs, the overall colour and appearance may be altered. See Figure 5.
